14 Longford Park, Longford, Newport,
Shropshire, England, TF10 8LW

This report contains

Schedule of Cleanliness and Condition

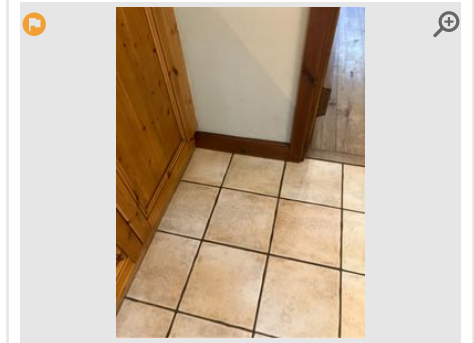
Provided by	Tenant
Captured (Certified by inspector)	16/08/2024
Added	19/08/2024
Reference	3.3.1

3.2 Door (Internal)	Hinged door Free of marks and scratches to front side and reverse.	● Good	● Good	2 photos
3.3 Door Frame & Skirting	Natural wood (frame). Natural wood (skirting) Free of marks, dents and dust.	● Good	● Good	6 photos
	Disagreed by tenant - 19th August 2024 ● The inspector agreed			
	Information provided by tenant Door frame loose
