14 Longford Park, Longford, Newport,
Shropshire, England, TF10 8LW

This report contains

Schedule of Cleanliness and Condition

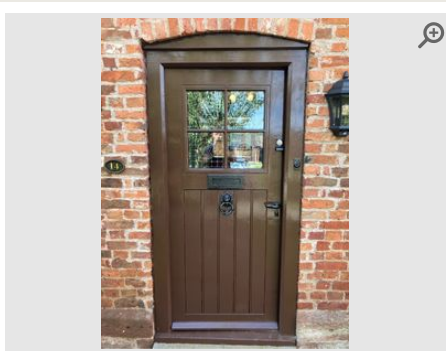
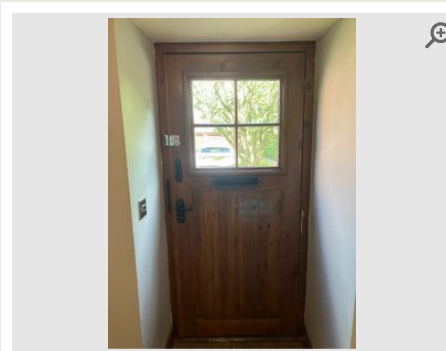
1.2 Front Door	Wood double glazed Free of marks and scratches to front side and reverse. Glazing in a good clean condition.	● Fair	● Good

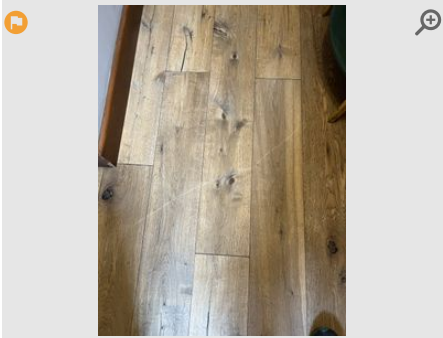
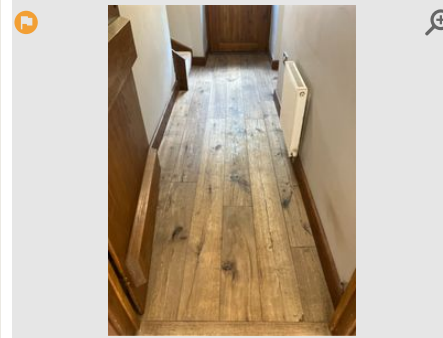
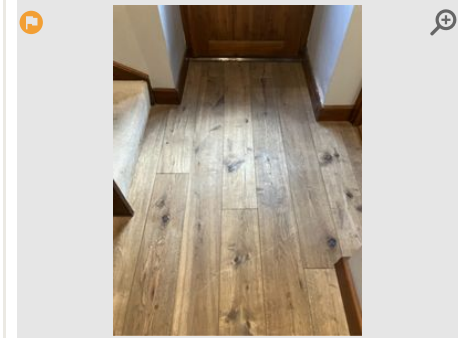
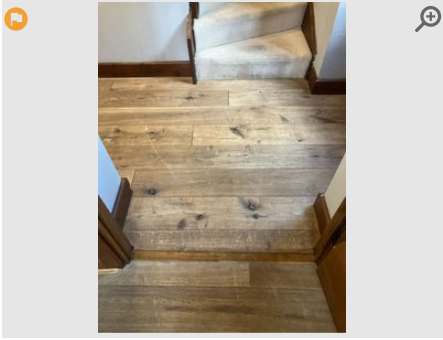
N/A
1.10 Floor	Laminate wood Free of stains, marks and scratches.	● Good	● Good

4 photos
	🚫 Disagreed by tenant - 19th August 2024 ● The inspector agreed			
	Information provided by tenant Mark on the floor

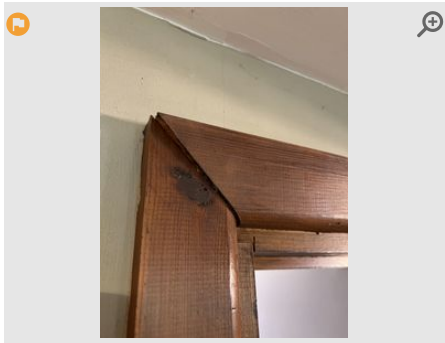
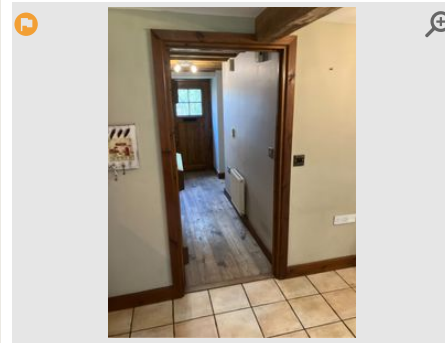
Provided by	Tenant
Captured (Certified by inspector)	16/08/2024
Added	19/08/2024
Reference	3.3.1

3.2 Door (Internal)	Hinged door Free of marks and scratches to front side and reverse.	● Good	● Good	2 photos
3.3 Door Frame & Skirting	Natural wood (frame). Natural wood (skirting) Free of marks, dents and dust.	● Good	● Good	6 photos
	Disagreed by tenant - 19th August 2024 ● The inspector agreed			
	Information provided by tenant Door frame loose

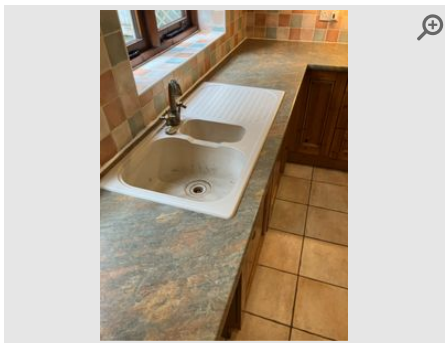
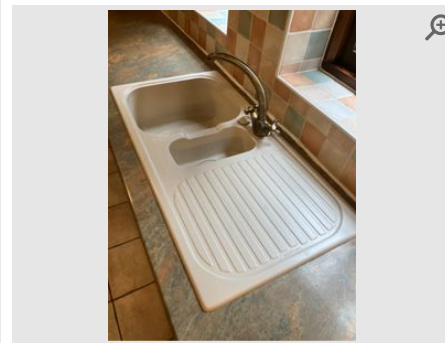
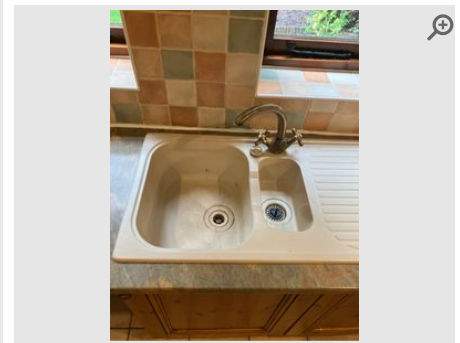
3.14 Kitchen Sink	Double bowl. Plastic Free of scratches and cracks. No food residue or grease present. Plug present.	● Fair	● Fair	3 photos
3.15 Hob	Ceramic hob. 4 rings Free of grease and food residue. Free of dust. Dials/knobs intact.	● Good	● Good	2 photos

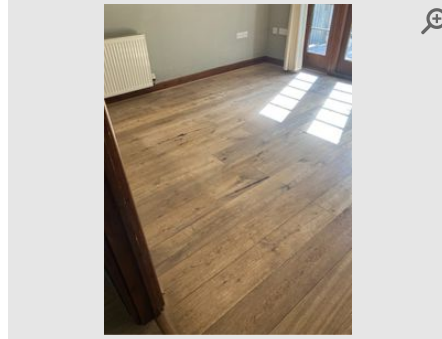
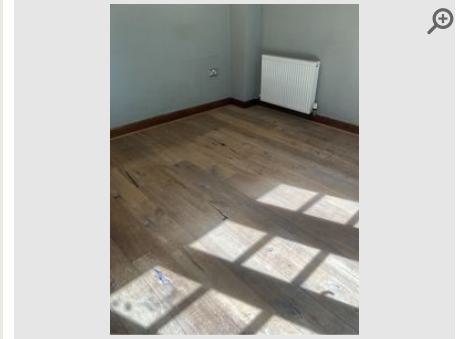
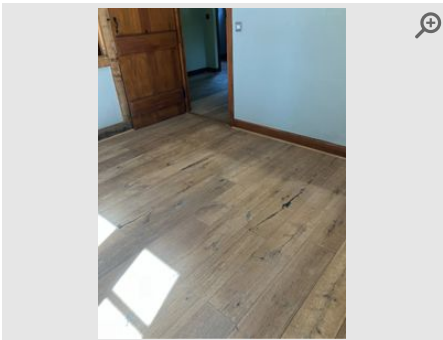
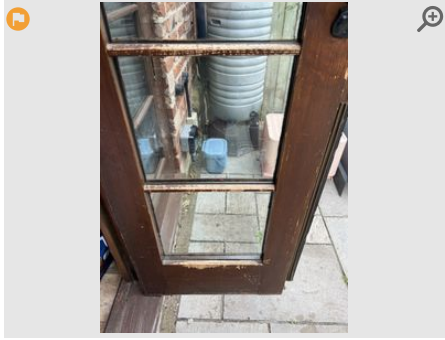
4.9 Floor	Laminate wood Free of stains, marks and scratches.	● Good	● Good

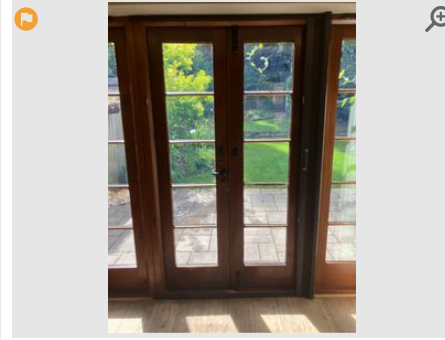
Provided by	Tenant
Captured (Certified by inspector)	16/08/2024
Added	19/08/2024
Reference	4.10.1

Disagreed by tenant - 19th August 2024		● The inspector agreed	
Information provided by tenant Wood worn

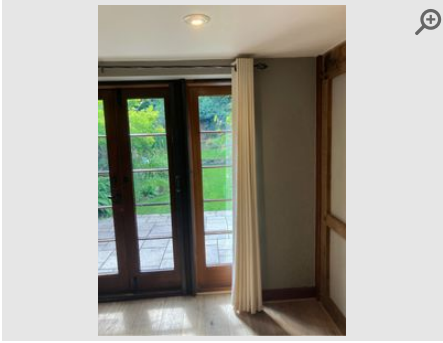
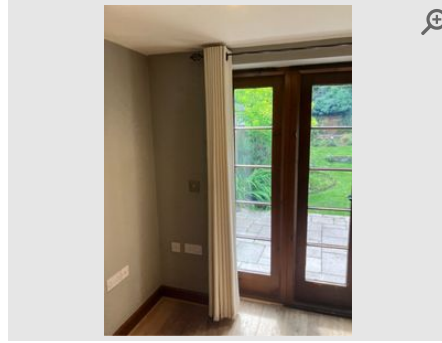
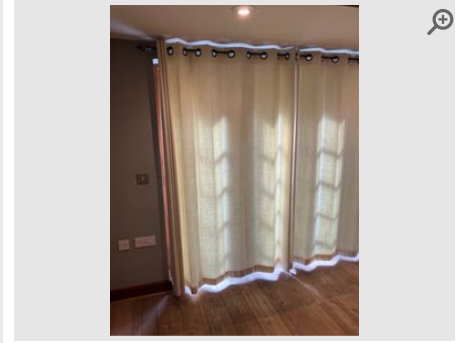
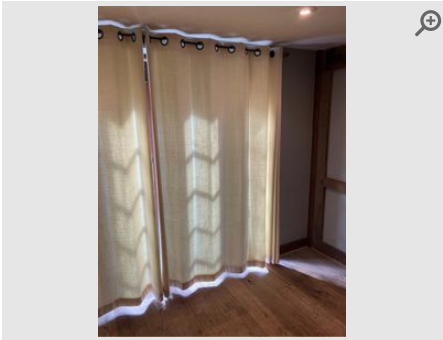
4.11 Curtains	Free of marks and stains See images.	● Good	● Good

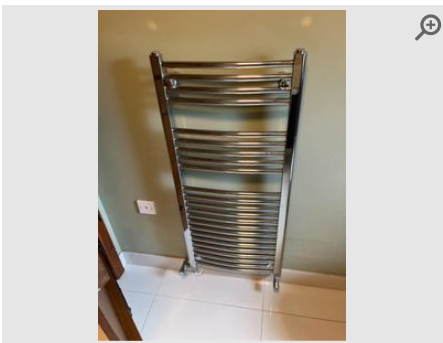
8.10 Radiator	Chrome ladder style Wall mounted radiator(s) free of marks and scuffs. All valve caps present and intact.	● Good	● Good	1 photo
8.11 Floor	Tiled Free of stains, marks and scratches.	● Good	● Good	3 photos

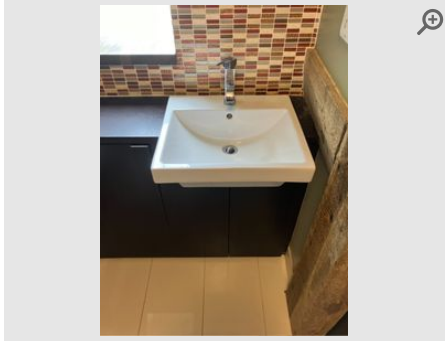
8.14 Sink/Basin	Countertop porcelain Basin intact and free of cracks/chips. No gaps to sealant around edges. Clean and free of hairs. No limescale present to taps.	● Good	● Good	1 photo

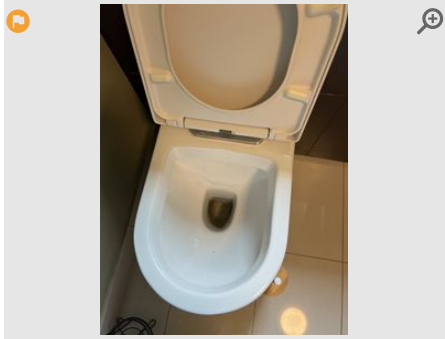
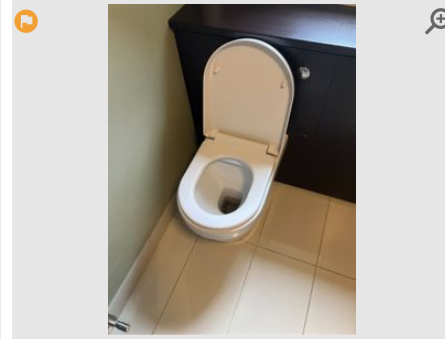
8.15 Toilet	Porcelain. Plastic/Acrylic seat & lid Free of cracks/chips. Flush intact. Seat secure and intact. Clean inside and to tank/base.	● Good	● Good	2 photos
		Disagreed by tenant - 19th August 2024		
		The inspector agreed		
		Information provided by tenant Black dirt in toilet

Provided by	Tenant
Captured (Certified by inspector)	16/08/2024
Added	19/08/2024
Reference	8.15.1

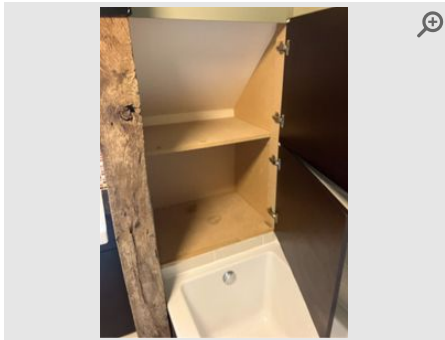
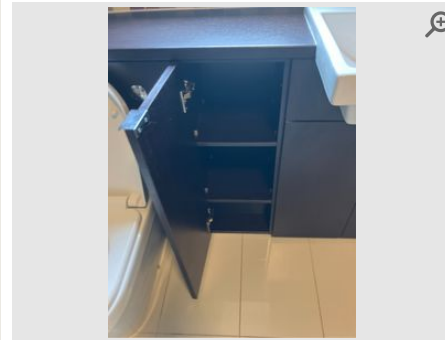
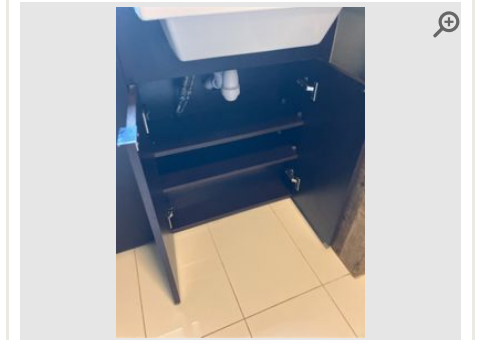
8.16 Cabinet	5 hinged doors Securely fixed to wall. Free of soiling/stains inside. Free of items inside. Hinges functioning well.	● Good	● Good	3 photos

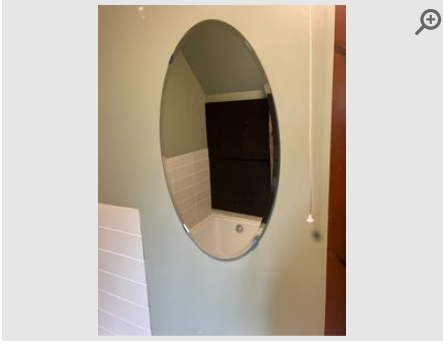
8.17 Mirror	Wall-mounted Wall-mounted and securely fixed. No cracks/chips.	● Good	● Fair	1 photo

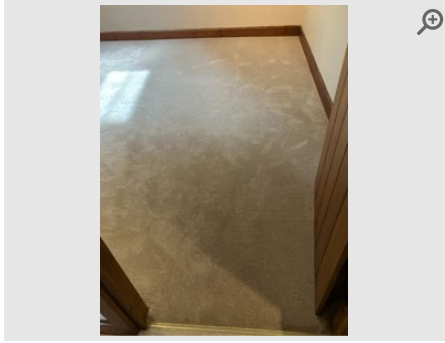
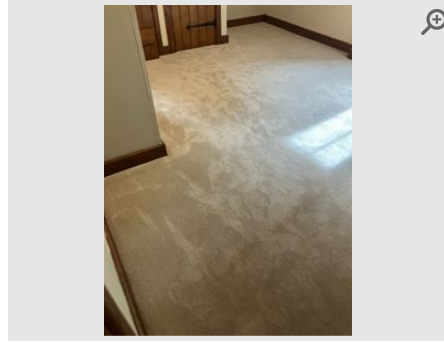
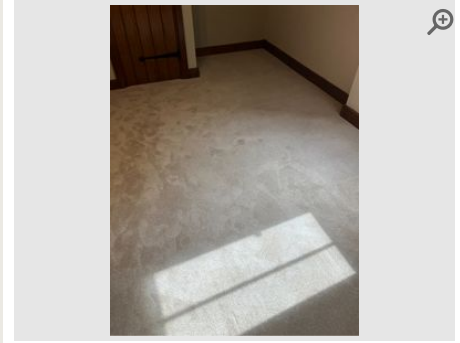
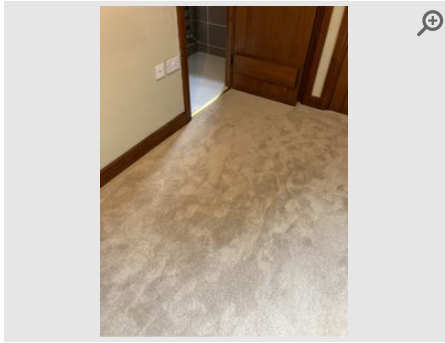
10.10 Floor	Carpeted Free of stains, marks and scratches.	● New Item	● Excellent

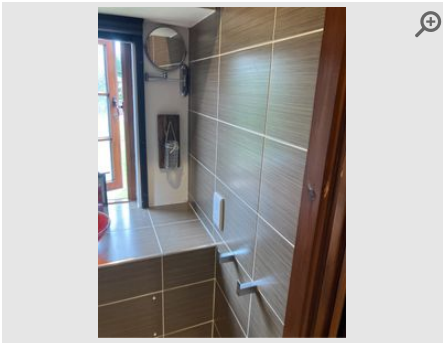
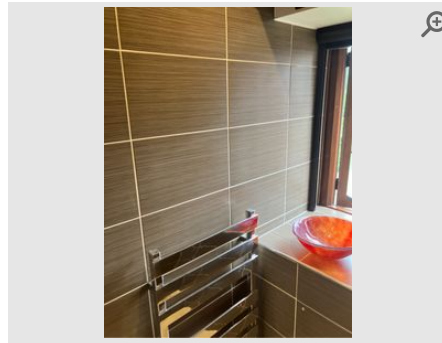
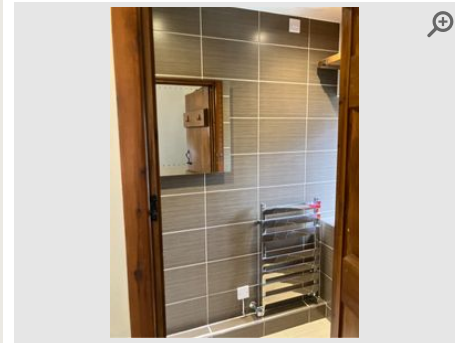
1 photo
11.7 Walls	Tiled Free of marks stains and scuffs. No picture hooks, raw plug or filled holes present.	● Good	● Good

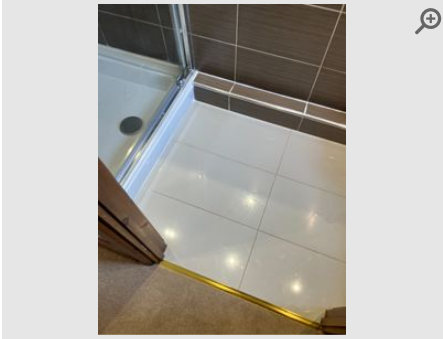
11.10 Floor	Tiled Free of stains, marks and scratches.	● Good	● Good

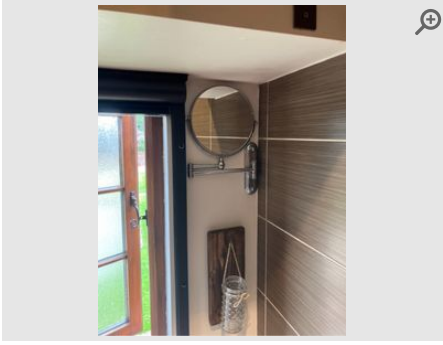
11.14 Mirror	Wall-mounted Wall-mounted and securely fixed. No cracks/chips. Free of smears and dust.	● Good	● Good

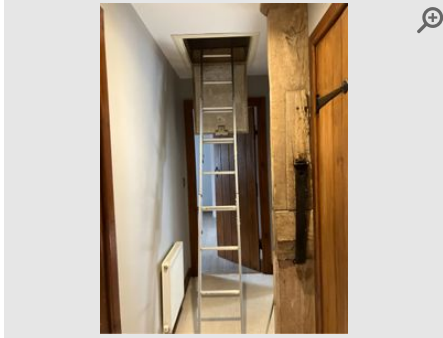
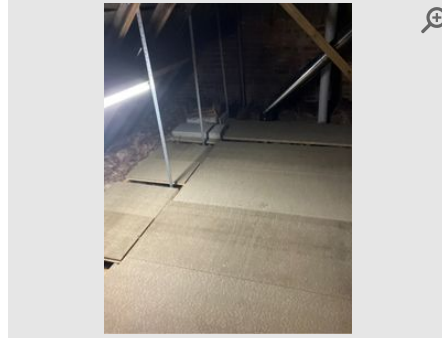
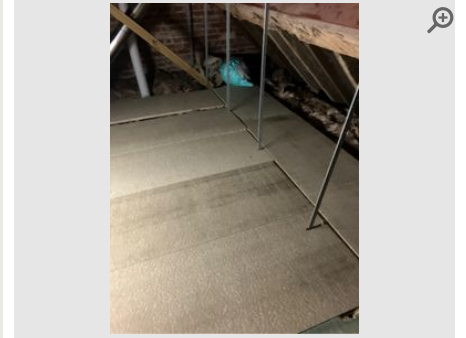
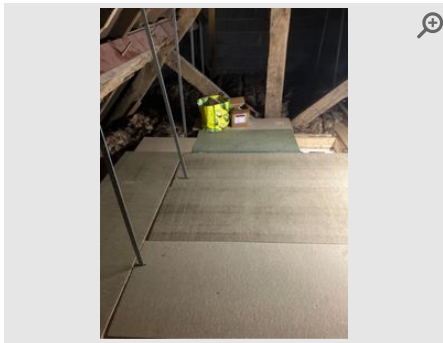
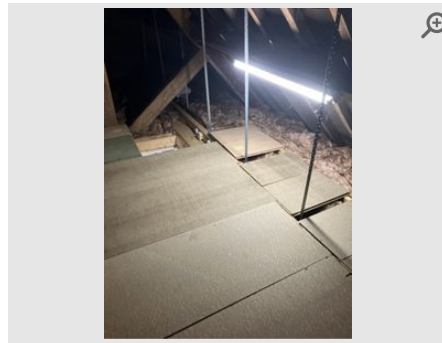
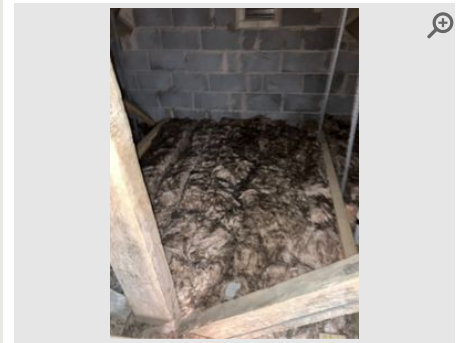
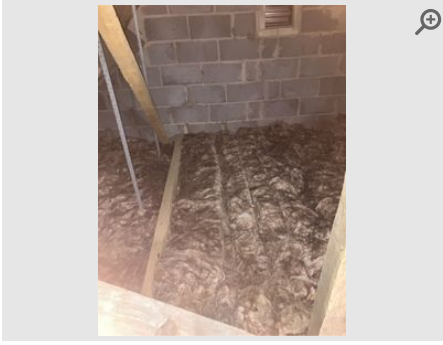
Item	Description	Condition	Cleanliness	Photos
12.1 General Overview	Clean & Tidy. Neutral smell/no odours evident No items remaining. Clean.	● Good	● Good	📷 7 photos

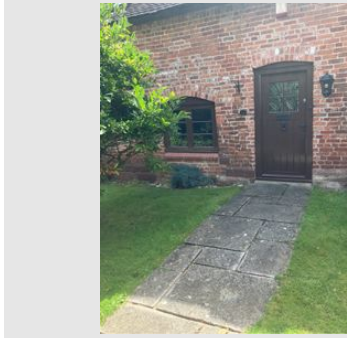
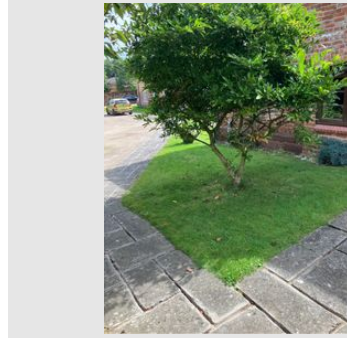
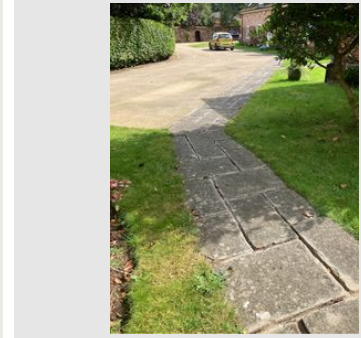
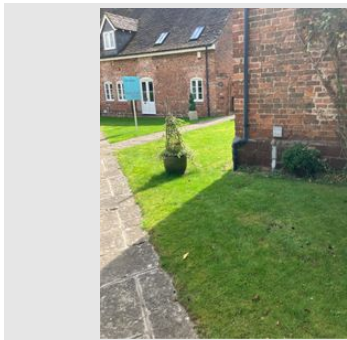
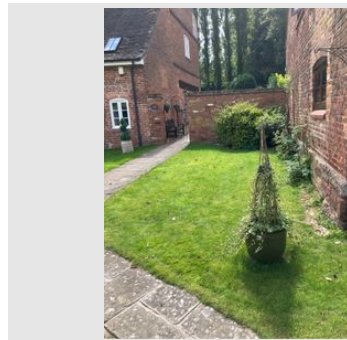
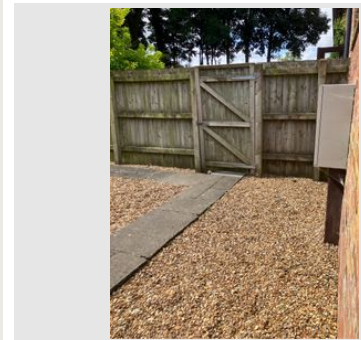
Item	Description	Condition	Cleanliness	Photos
13.1 Overview (External)	Good seasonal order Good seasonal order. No rubbish present.	● Good	● Good	📷 6 photos

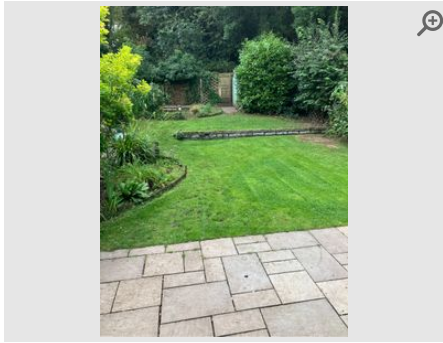
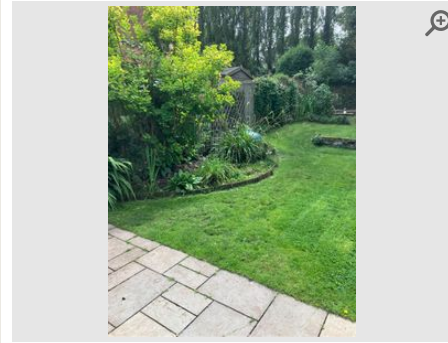
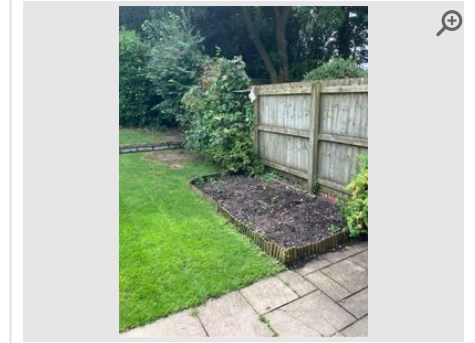
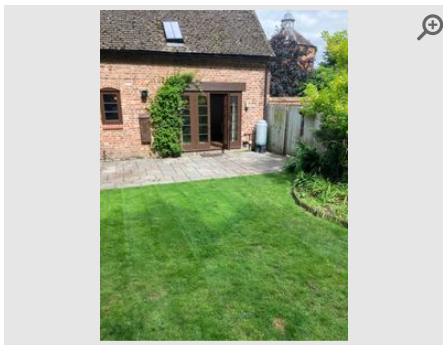
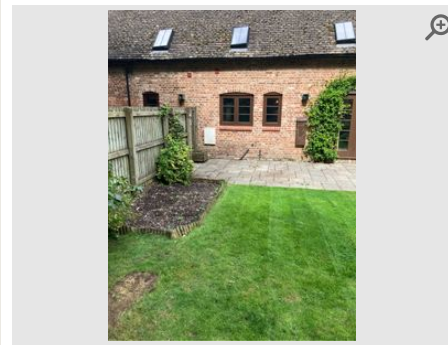
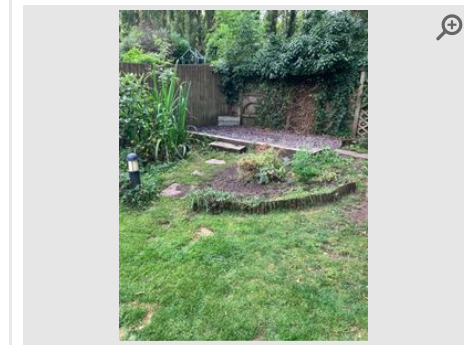
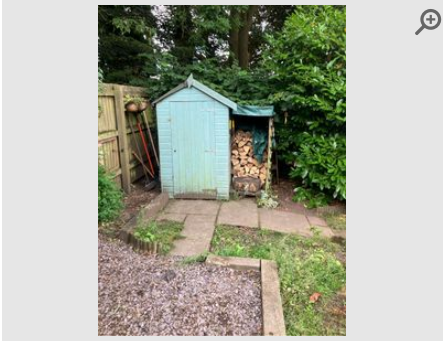
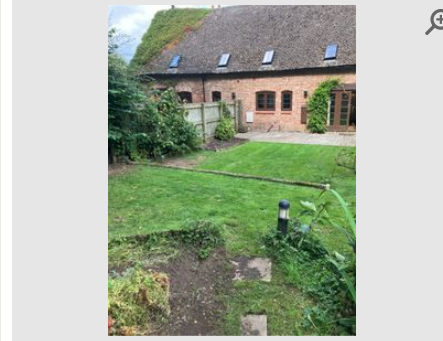
Item	Description	Condition	Cleanliness	Photos
14.1 Overview (External)	Good seasonal order Good seasonal order. Fencing appears secure. No rubbish present.	● Good	● Good	📷 8 photos
14.2 Shed	Wood panelled Hinged door with padlock present. Free of items inside.	● Fair	● Fair	📷 2 photos

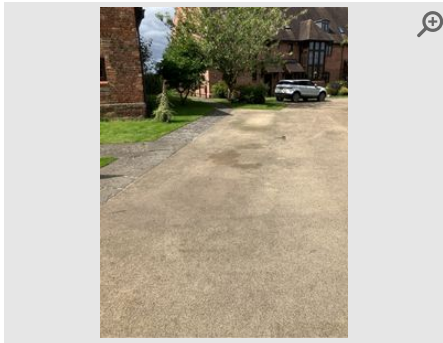
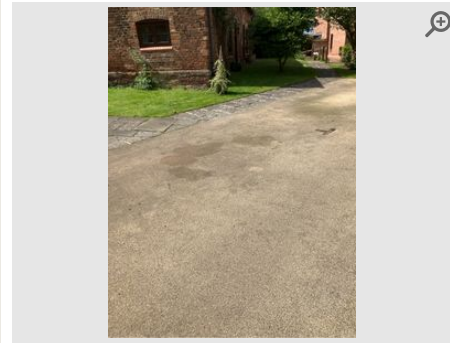
Item	Description	Condition	Cleanliness	Photos
15.1 Overview (Parking Space)	Tarmacked area See images.	● Good	● Good	📷 2 photos

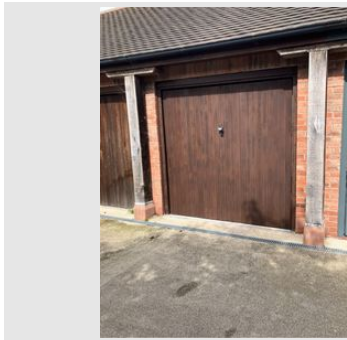
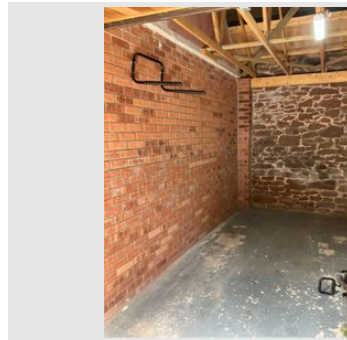
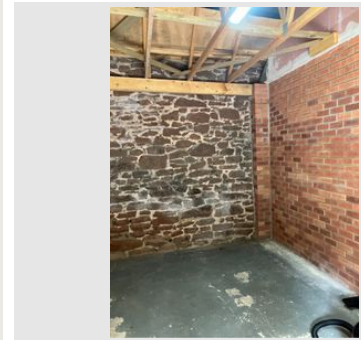
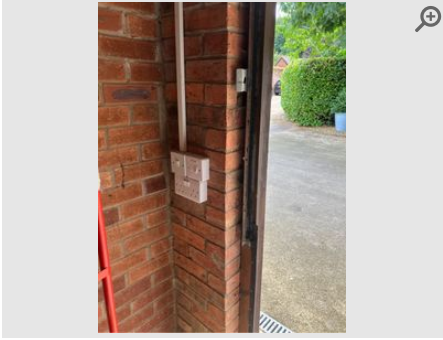
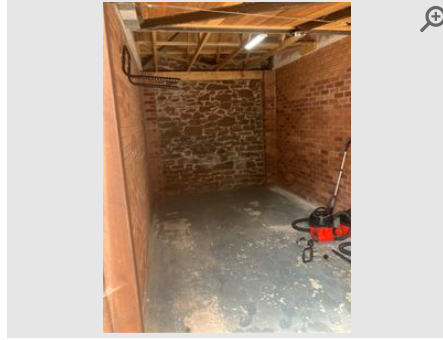
Item	Description	Condition	Cleanliness	Photos
16.1 Overview (Garage)	Manual up & over door. Smooth opening Empty inside. Free of rubbish. Garage door in working order.	● Good	● Good	📷 5 photos
16.2 Floor (Garage)	Free of oil and paint stains.	● Good	● Good	📷 N/A
16.3 Walls (Garage)	Free of oil and paint stains.	● Good	● Good	📷 N/A
16.4 Ceiling (Garage)	Intact and free of damage.	● Good	● Good	📷 N/A
16.5 Garage Door	Runners intact and functioning well.	● Good	● Good	📷 N/A
16.6 Sockets & Switches	All sockets and switches present and intact.	● Good	● Good	📷 N/A
16.7 Light Fittings	All bulbs in working order.	● Good	● Good	📷 N/A
